Manhole Inspection Summary

Manhole # S13U__007MH

Insp Date: **3/17/08 8:36 AM**

Location Address: **1018 Benson Cowan**

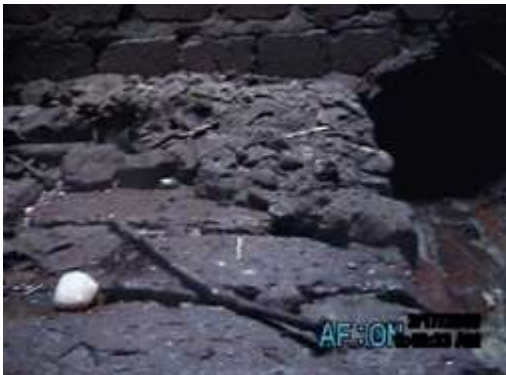
misc

debris on bench

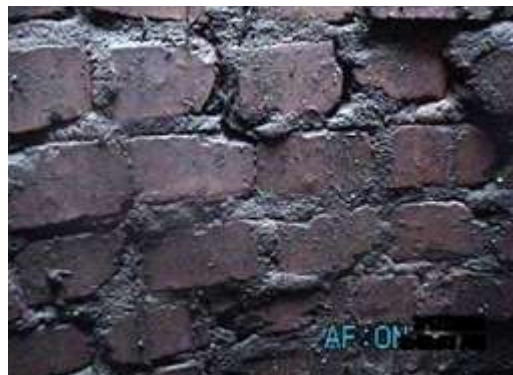
Defect 5

Infiltration: ☐ None ☐ Joint ☐ Cracks ☐ Mortar ☐ Roots ☒ **Wall**

infiltration on the walls of barrel

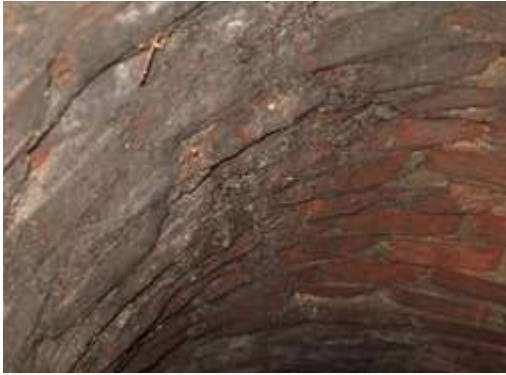
Defect 3

Infiltration: ☐ None ☐ Joint ☐ Cracks ☐ Mortar ☐ Roots ☒ **Wall**

infiltration on the walls of the corbal.

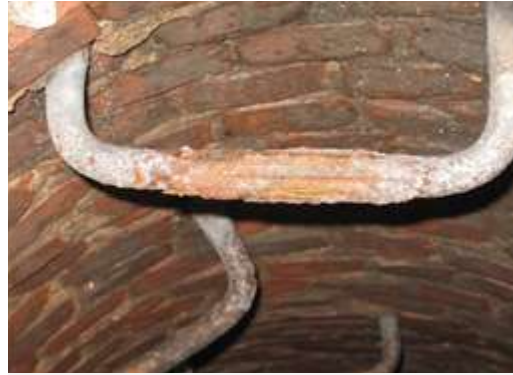
Defect 2

Steps Count: **4** Missing: **0** ☒ **Corroded**

corroded steps

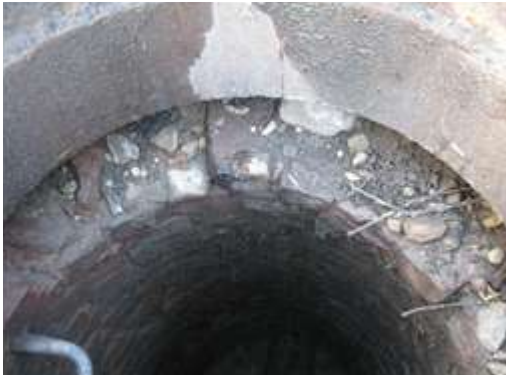
Defect 1

Condition: ☐ Sound ☐ Cracked ☐ Root Intrusion ☒ **Loose Brick** ☐ Deteriorated

Infiltration: ☐ None ☐ Joint ☐ Cracks ☐ Mortar ☐ Roots ☒ **Wall**

loose bricks and mortar at chimney/
evidence of chimney infiltration.

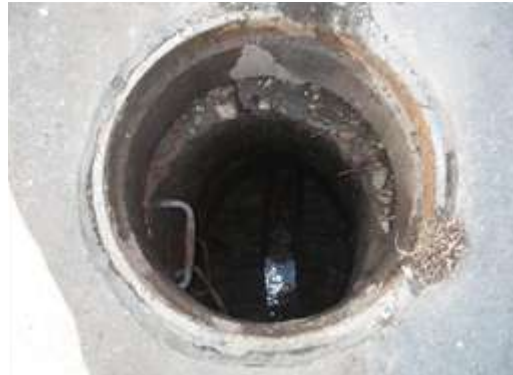
Defect 6

Frame Offset: **3** (in.) Condition: ☐ Sound ☐ Cracked ☒ **Leaks**

frame leaks-sheeting evidence, frame
offset
